# THERMOGRAPHIC REPORT

Company | SUB BOARD  
Problem # | LOOSE TERMINAL

Location Name | Location 10  
Equipment | MAIN SWITCH

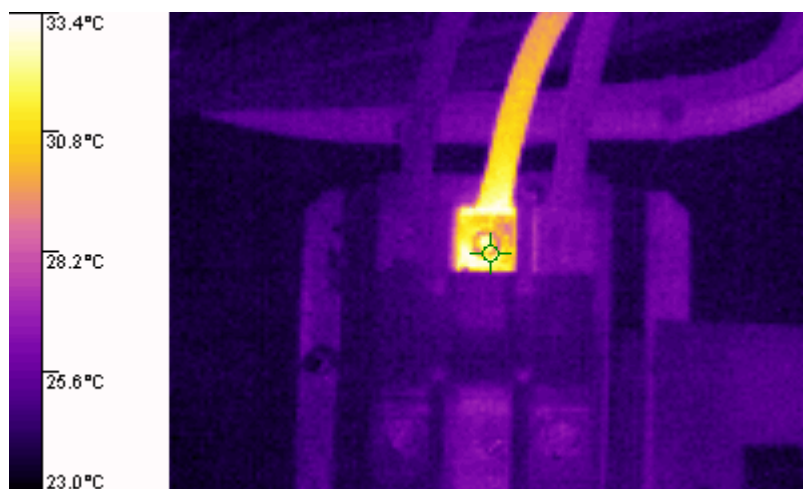
## THERMOGRAM

LOOSE TERMINAL ON MAIN SWITCH

Image Date	11/05/2004 2:06:42
Target Temperature	29.7 °C
Emissivity	0.98
Reflected Temp	28.0

Distance	Rated Load	Meas. Load	% Load
80cm	250 A	90A
